Villisca National Guard Armory
Villisca, Montgomery County, Iowa
April 24, 2008
ARCH 567 - Preservation, Restoration, and Rehabilitation
Professor Arvid Osterberg

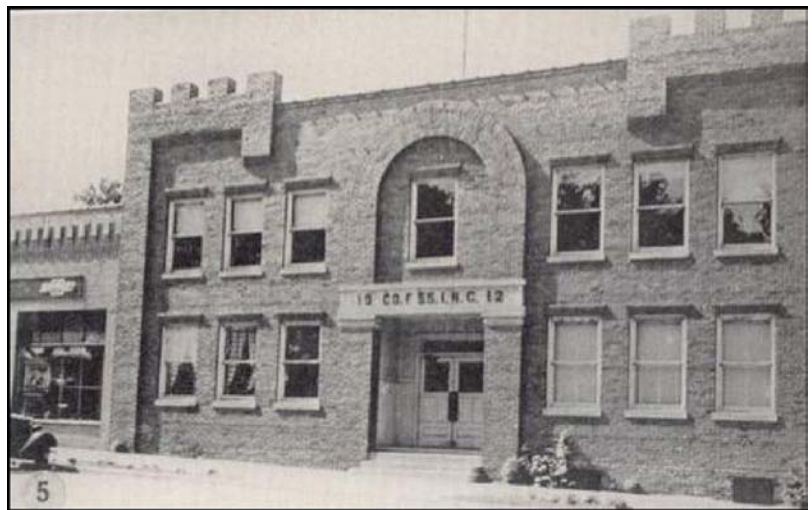
Figure 1. Front Facade from 1938 IAARNG Annual

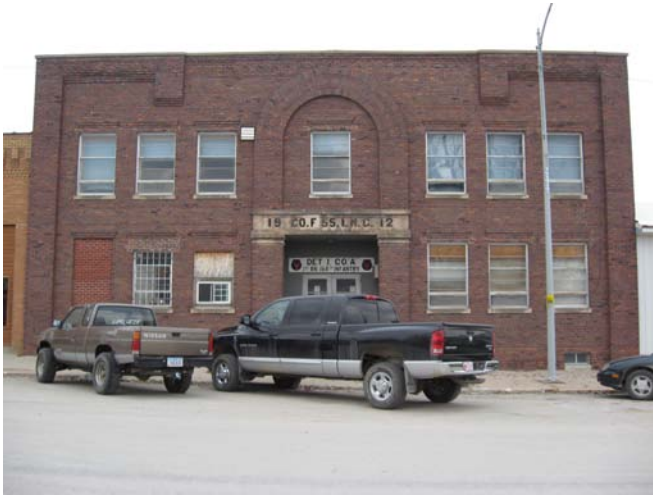
Figure 2. Personal Photograph, 3-28-08

çade has a recessed central entry marked by a corbelled brick archway with precast concrete lintel and accent details. A single window sits directly above the entryway on the second floor. The lintel has a nameplate highlighted in black reading "10Co. F 55 I.N.C. 12". The front double doors are metal replacement doors from 1949, where concrete steps lead up to the front door, which are also replacements of the original concrete steps and landing. A painted sign over the door reads "DET 1. CO. A / 1st BN. 168th INFANTRY," with the symbol of the Red Bull Division. The entryway is also flanked by symmetrically placed triple sets of windows across the second and first floor façade. The windows are primarily double-hung windows with an interesting 2/3 pane pattern using only horizontal muntins. The set of three windows on the first floor to the left of the entryway has a window with a gridded bar pattern, while two have been replaced, one being completely bricked in, while one has been removed and replaced with plywood and wall air-conditioner (for purposes of a computer room in 2000-2001). The lintels are corbelled brick, while the sills are precast concrete. The windows are all replacements dating from the 1950s-1960s (Fig. 2).

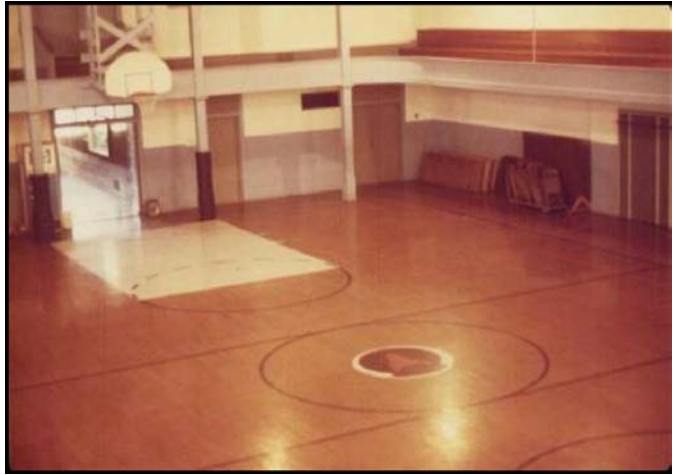
Figure 3. Interior looking to SW - 1994 IAARNG Annual

The interior of the armory has two full floors and a partial basement. The first floor has a central hall flanked by offices and storage space to either side in the south half of the building, as well as toilets. The staircases are also located in this area of the building. The majority of the floor to the north is a large hall used primary as a gymnasium that is open to the second

floor ceiling. That ceiling is covered with the original pressed tin ceiling. The north wall has two sets of two large windows with a fire exit at the northwest corner. A door at the northeast corner opens to a flight of stairs down to the added on garage (Appendix 1, Fig. B). The east, west, and south walls of the gymnasium have a balcony level on the second floor, which is lined with benches, and is supported by square wooden columns. The second floor has 3 classrooms, and 2 smaller rooms in the south half, with the balcony level encompassing the north half of the building (Fig. 3). There are also fire escape doors located at the end of the balcony at the north wall on both the west and east (Appendix 1, Fig. C). The basement has bathrooms, a lounge,

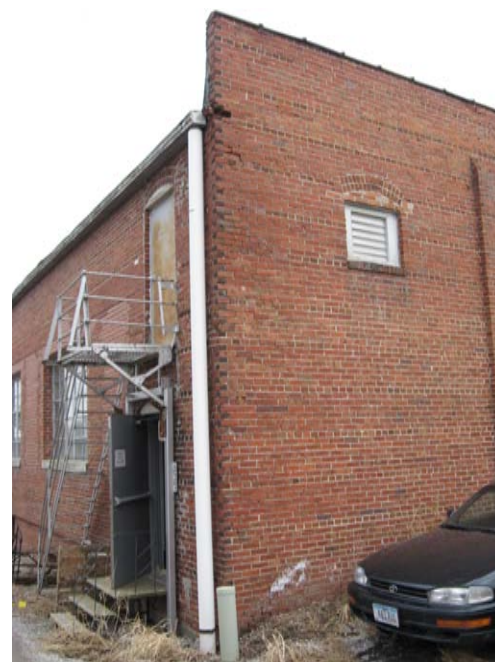
Figure 5. NW corner - Personal Photograph, 3-28-08

out and need replacing (Fig. 5). On the backside, there is evidence of past repointing, which is very evident. It looks as though 3 windows were filled in with brick. Overall, there doesn't seem to be any too big of issues on the backside or sides. On the front façade, the brick is in fairly good condition with some exceptions of cracking and some of the

mortar has eroded away (Fig. 6). Since the mortar is tinted red and has a coarse aggregate, if repointing is to take place in various locations, matching the mortar is probably the most important thing. Also, without close inspection, the brick and mortar should probably be inspected at the roofline. From general pictures, it looks as though some of the mortar has eroded. This is an instance where the root of the problem needs to be fixed, which is the roof. While repairs of the roof are taking place, special note needs to be taken to seal well the areas around the parapet.

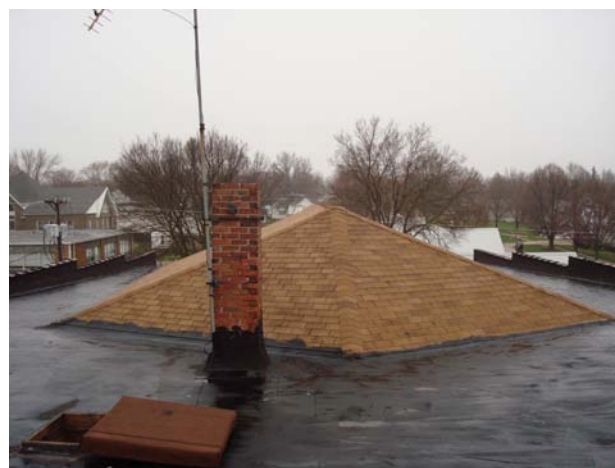
Figure 7. Roof facing north - Photograph by Stan Schaaf 4-17-08

The major concern to address at this time, and possibly the largest and most expensive project to take on is repair of the roof. Major problem with leaking have been taking place at an accelerating pace in the last few years. It is important to note that repairs have taken place recently (after VHS took possession). The pitched roof over the gym area was reshingled, which the flat area over the south end and around the north end (that of which drains to the north) was re-tarred (Fig. 7). The design of the roof is a challenge because of the combination of the two types of roofs, and the recent repairs obviously haven't succeeded in preventing leaks. Thankfully the roof is not very visible and does not affect the architectural character. Before any action should take place, a complete internal and external inspection of the roof should be planned to determine all the causes of failure and to identify the alternatives for repair or replacement¹⁹. With the design of this roof, the root of the problem is that all the water drains to the south but is funneled into two small streams on the sides of

the gabled roof. The gutters and downspouts may or may not be able to handle all the water, especially in hard downpours.

Because the roof is not visible and does not compromise the architectural character the brief notes that “if the roof is flat and is not visible from any elevation of the building, and if there are advantages to substituting a modern built-up composition roof for what might have been a flat metal roof, then it may make better economic and construction sense to use a modern roofing method.” This is a concern that needs to be addressed as soon as possible and probably the first job to be undertaken.

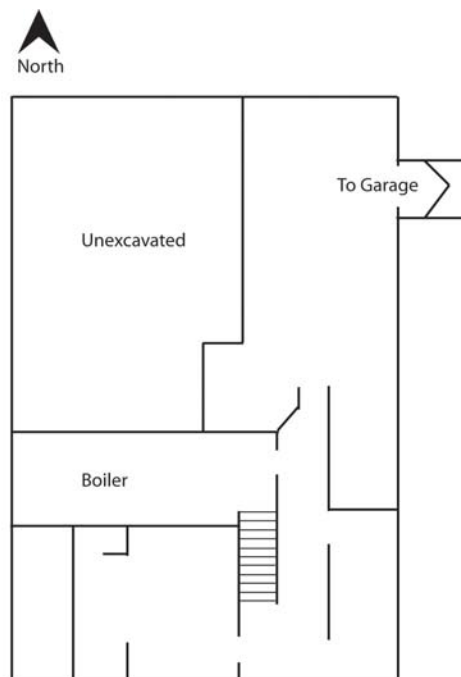
Figure B
Basement Floor Plan

boiler room, old locker rooms, and a rifle range that was converted into a locker room. To the west of the former rifle range is an unexcavated area of the basement level that likely helped soundproof the rifle range (Appendix 1, Fig. D). When VHS took ownership of the Armory, the basement level, specifically the former rifle range area was converted into the lunchroom, with a section in the southeast corner serving as the kitchen.

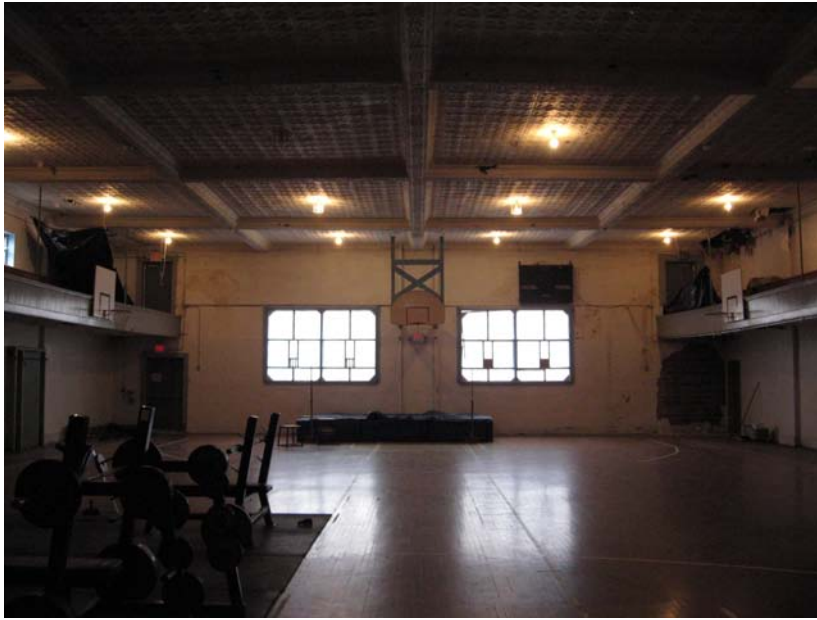
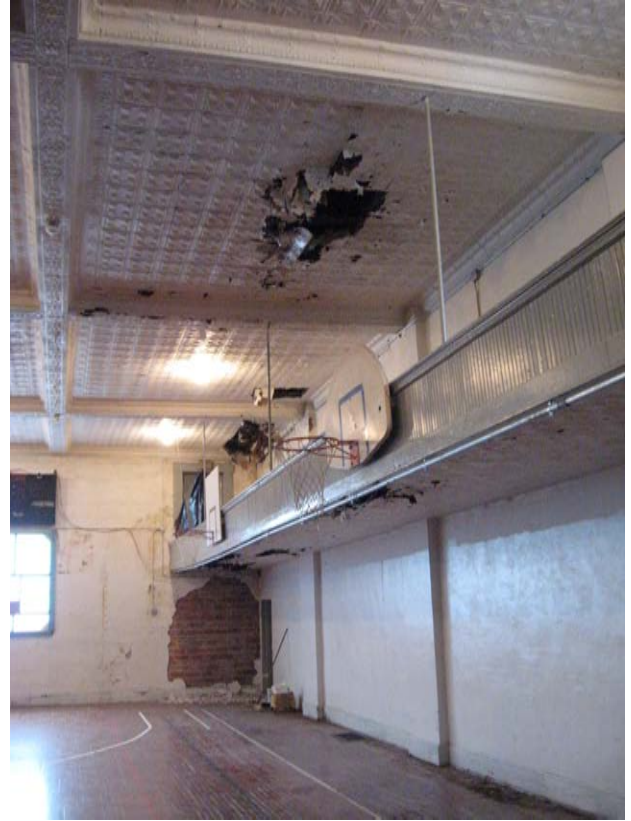
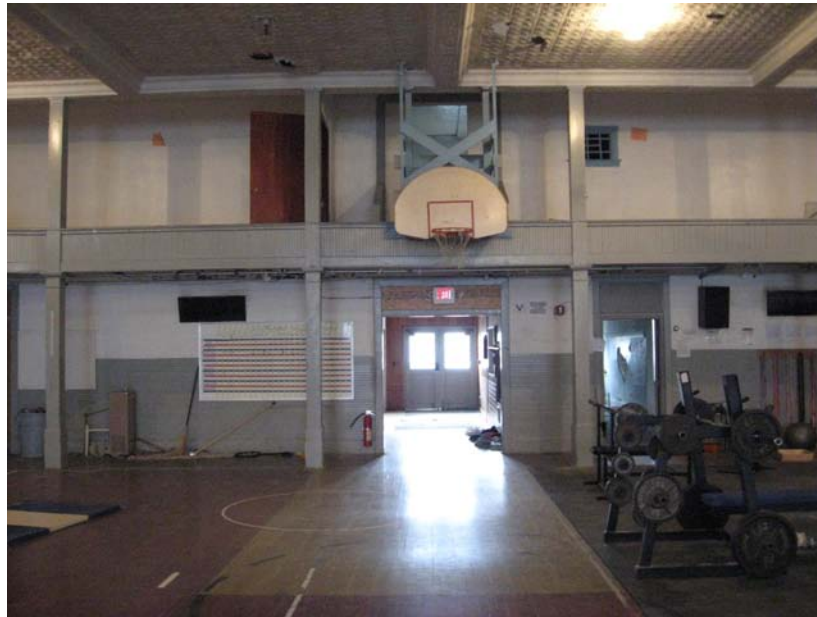
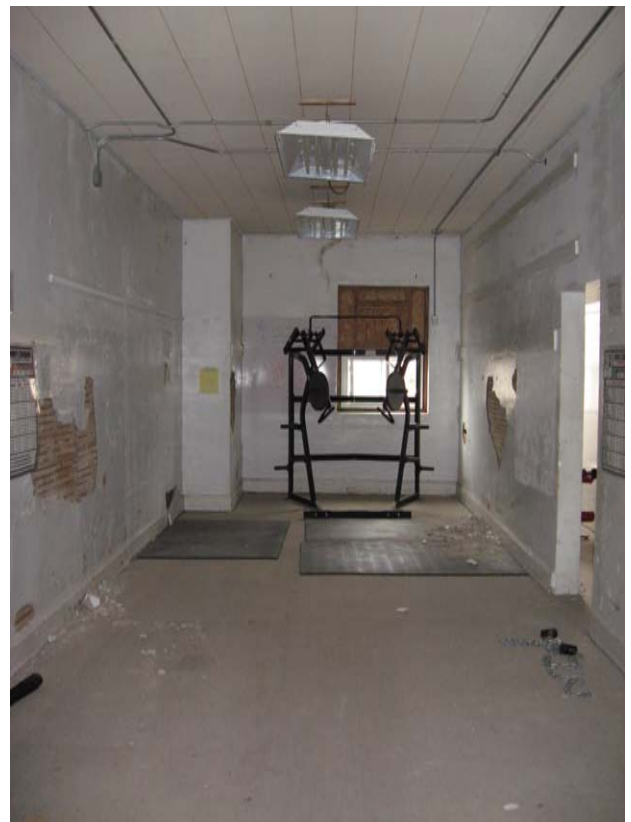
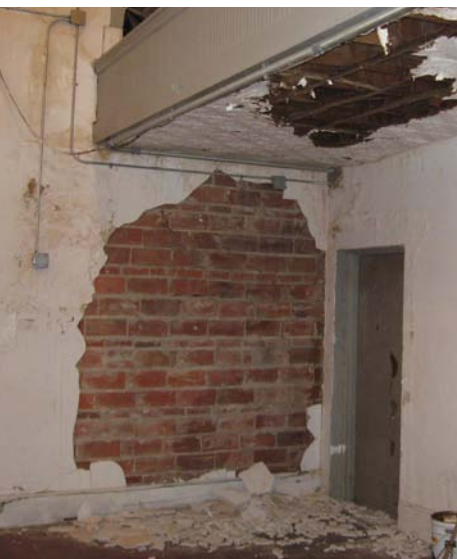
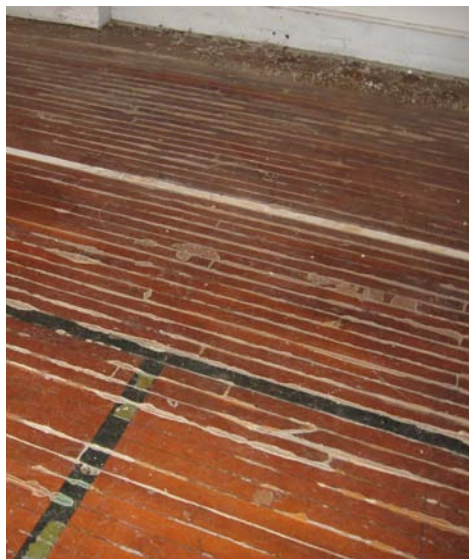
Clockwise from top left: Gymnasium looking north, Balcony on east side of gym, South room west of main corridor, Evidence of gym wood floor water damage, NE corner of gym, Looking south to main entrance.

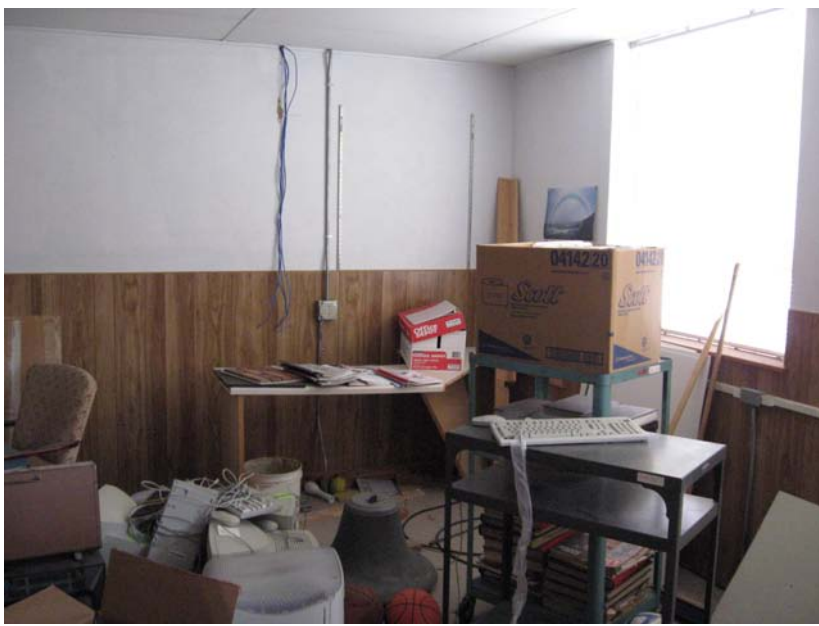
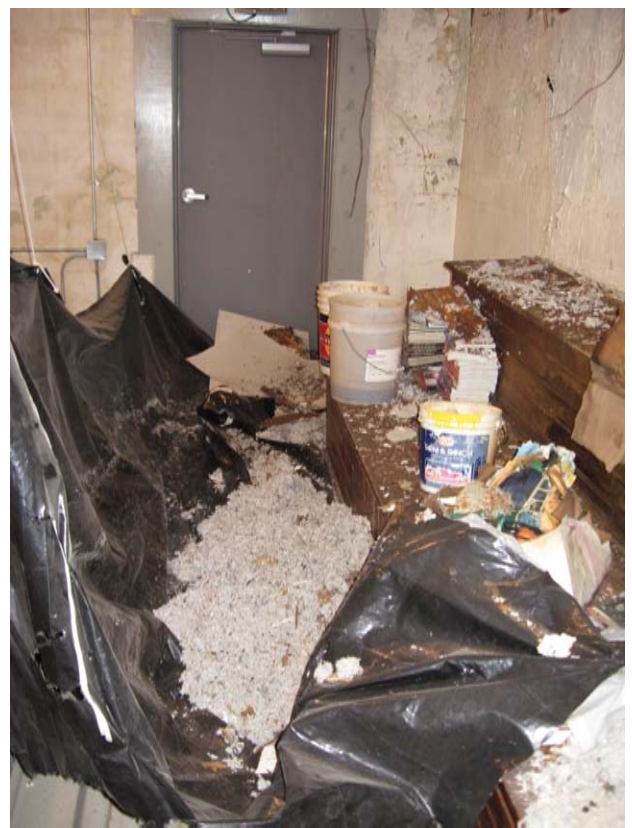
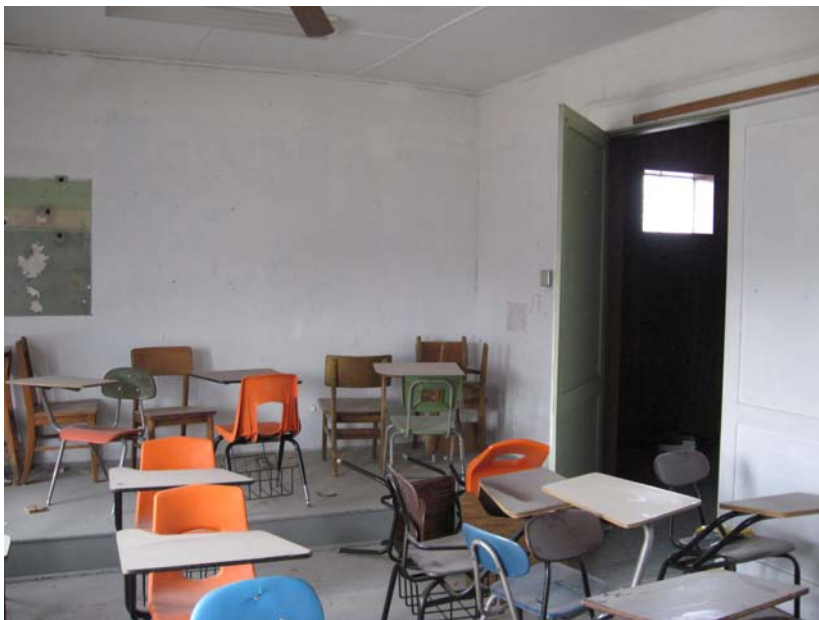
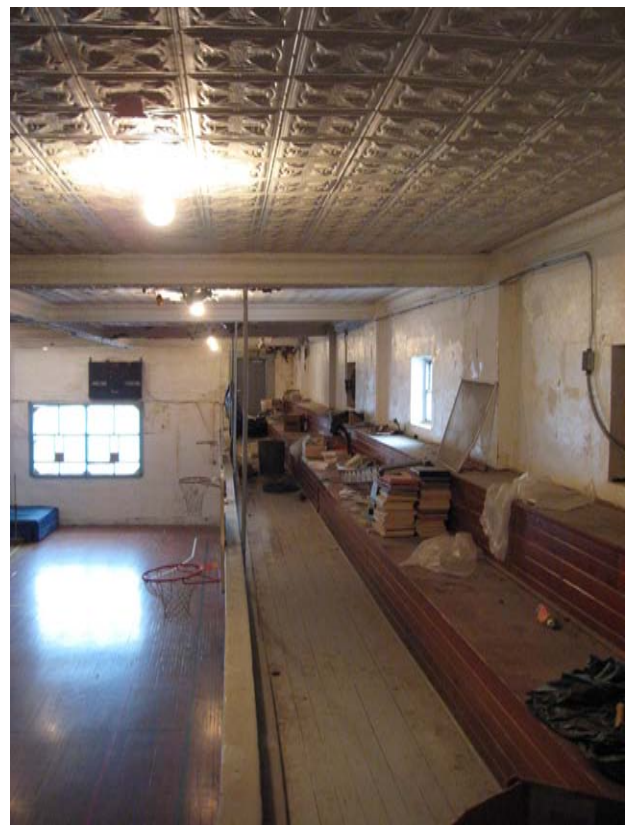
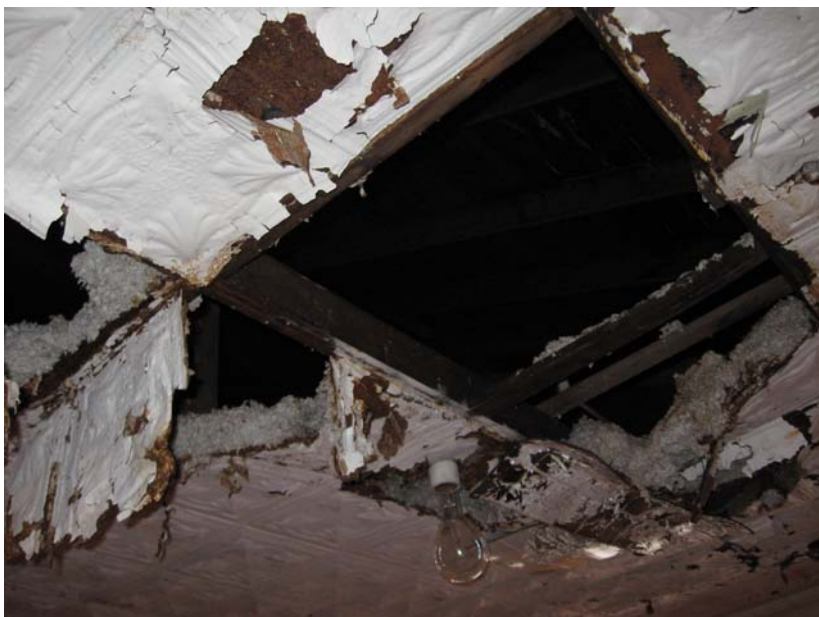
Clockwise from top left: Office on main floor east of main corridor, On east balcony, East balcony, Damage of original pressed tin ceiling, Upper level classroom.

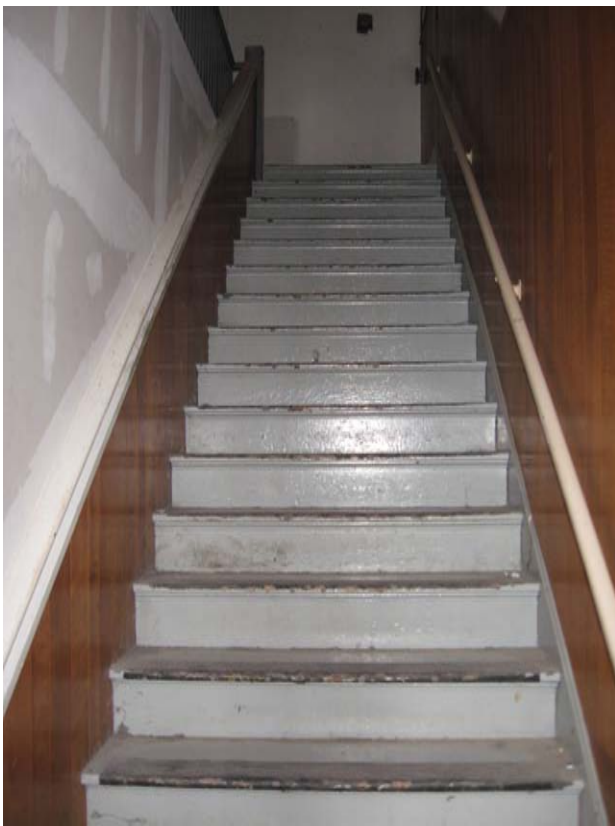
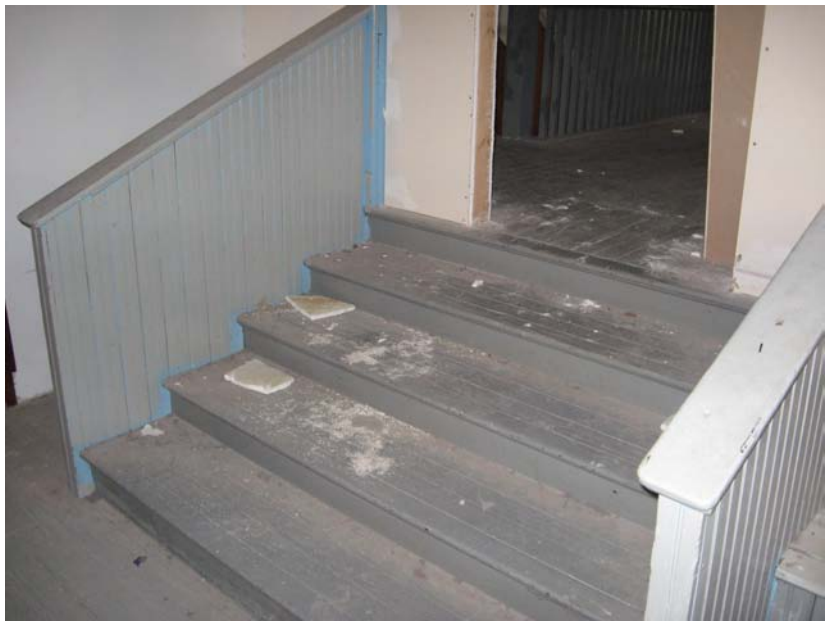
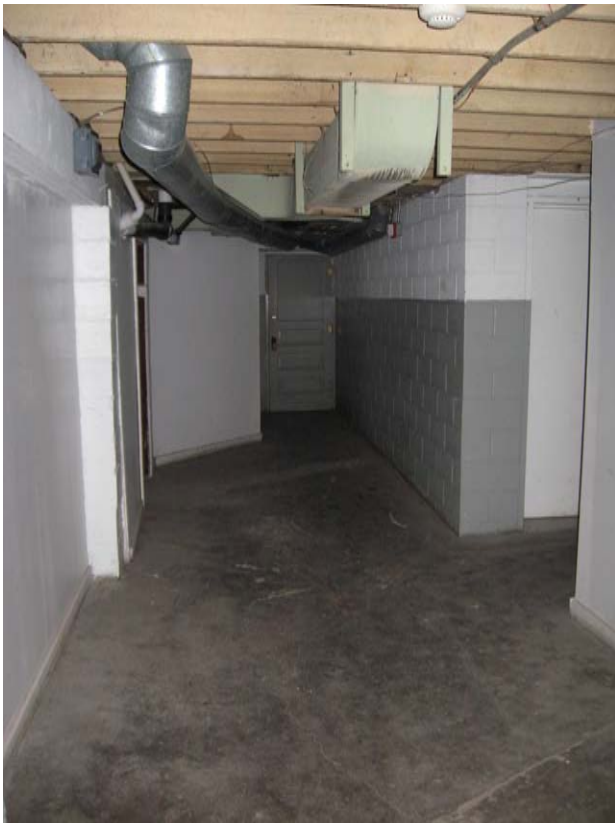
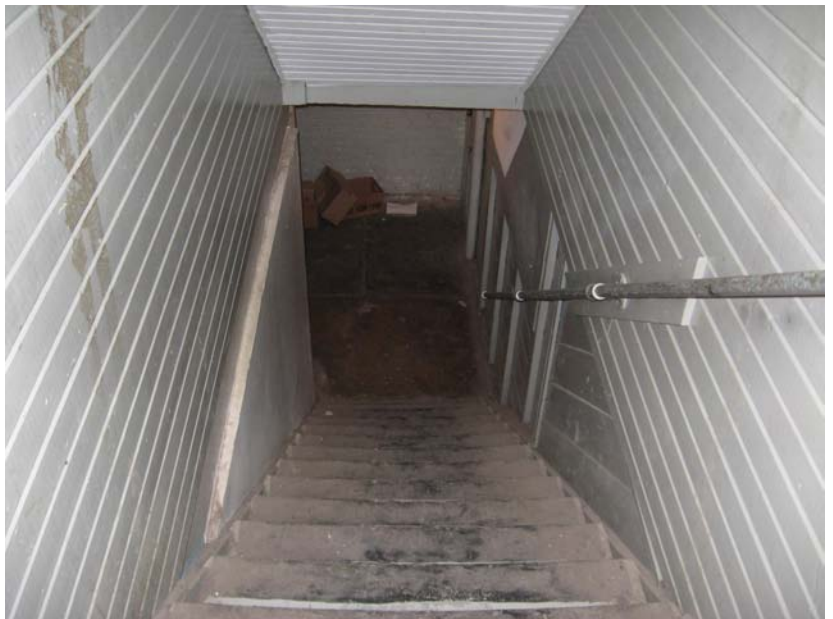
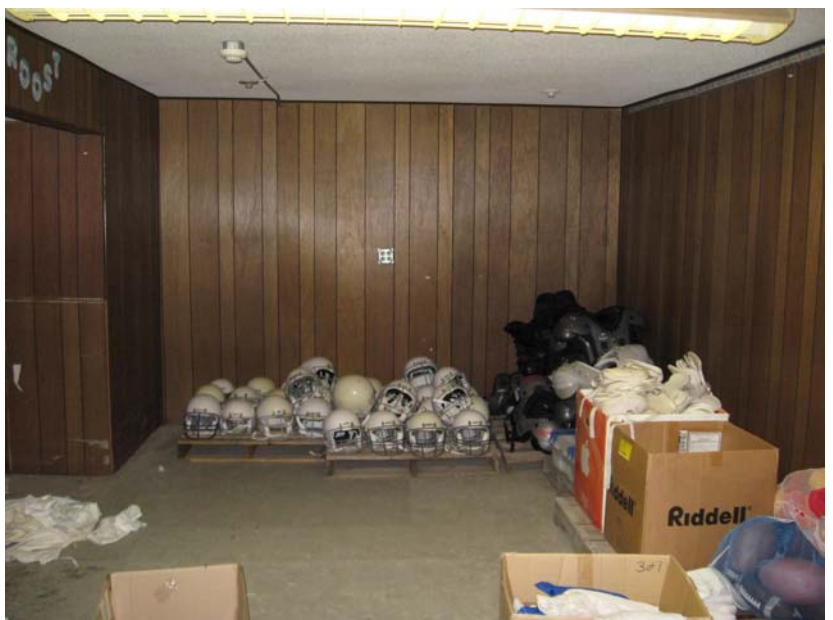
Clockwise from top left: Stairs from main floor looking to upper floor, Stairs from upper level onto balcony, Stairs leading down to basement, Basement room, Corridor in basement looking north.

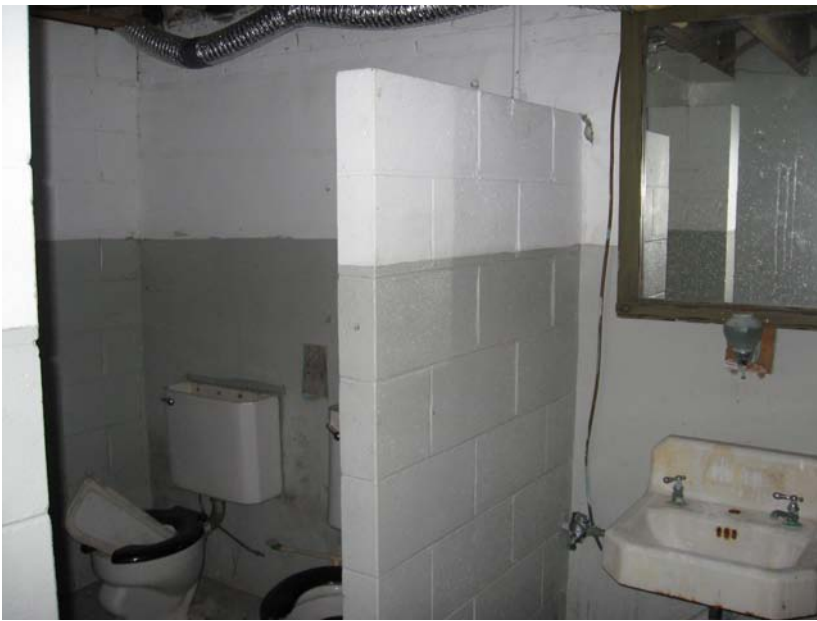
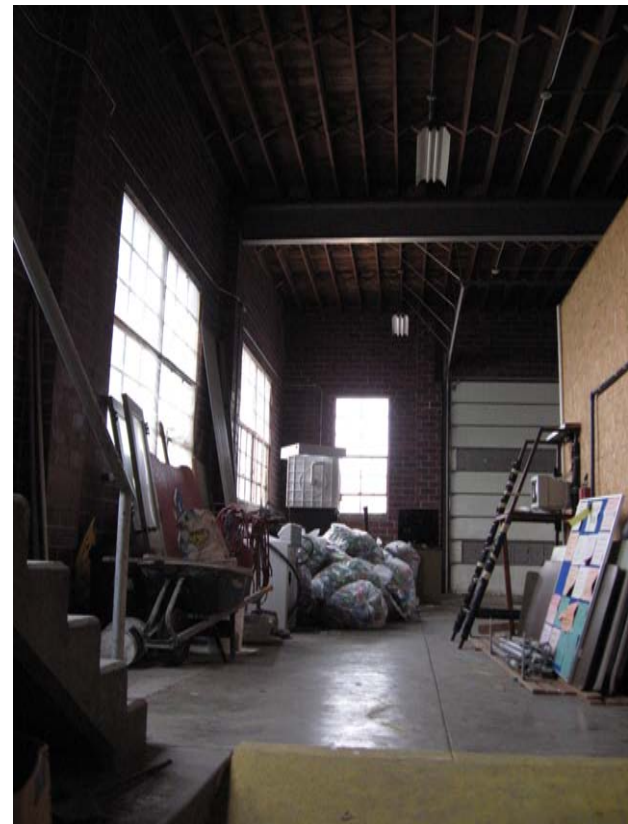
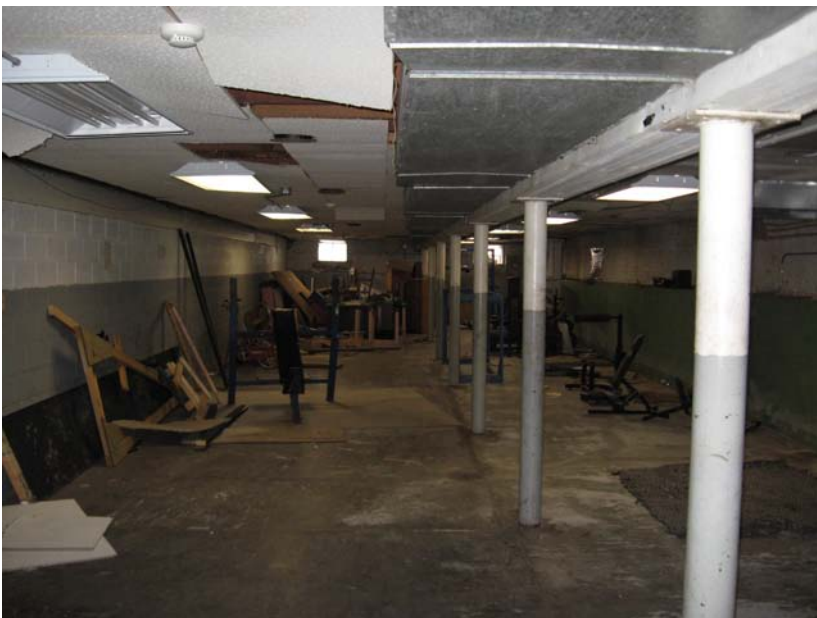
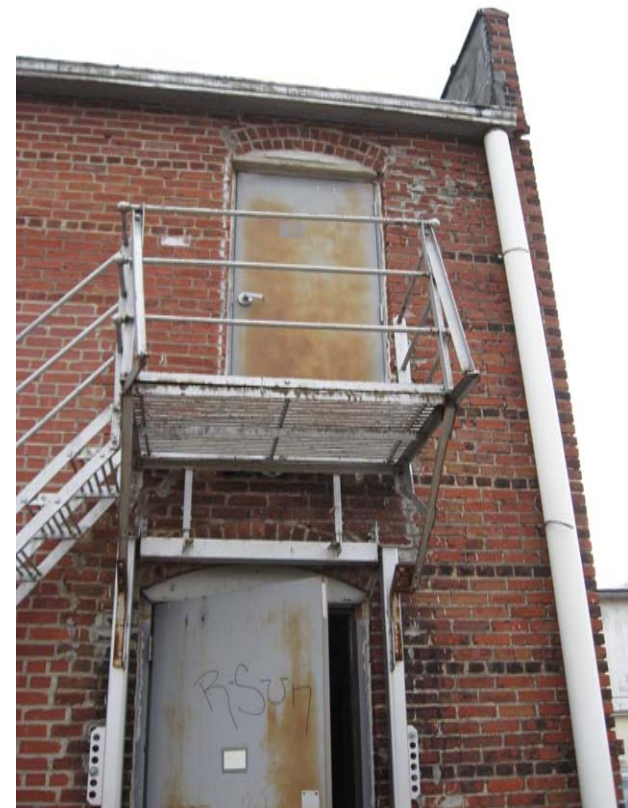
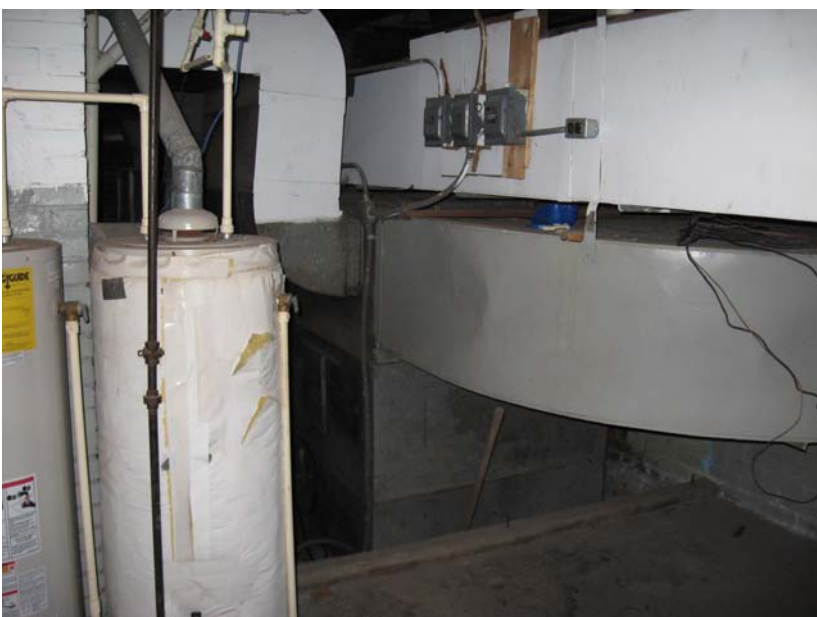
Clockwise from top left: Bathrooms in basement, Looking at added-on garage at northeast corner, Fire escapes at northwest corner, Boiler in basement, Old firing range in basement looking north.

Additions to the building have included a garage for the armory, measuring approximately 59' by 39', added to the northeast corner in 1954, which was built with textured tile brick walls and concrete block foundation. A modern garage abuts the southeast corner but is not associated with the armory building.

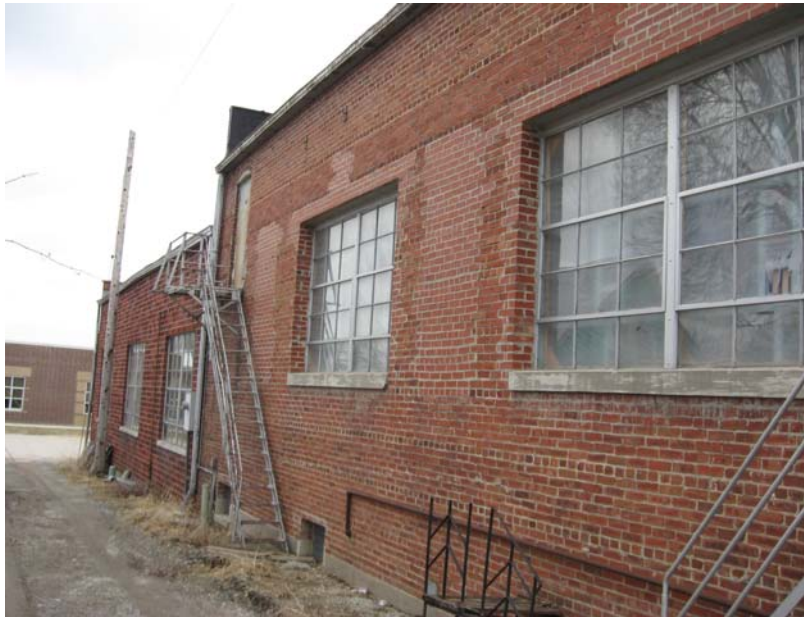
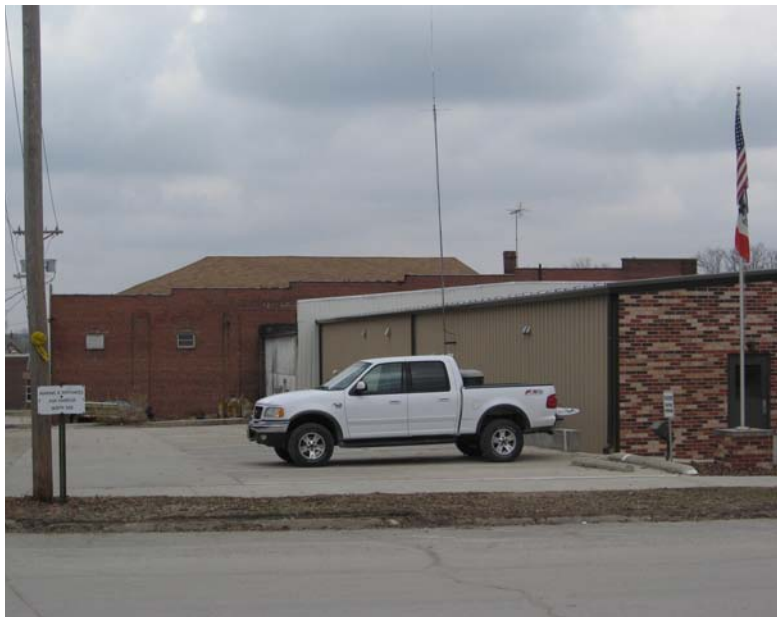
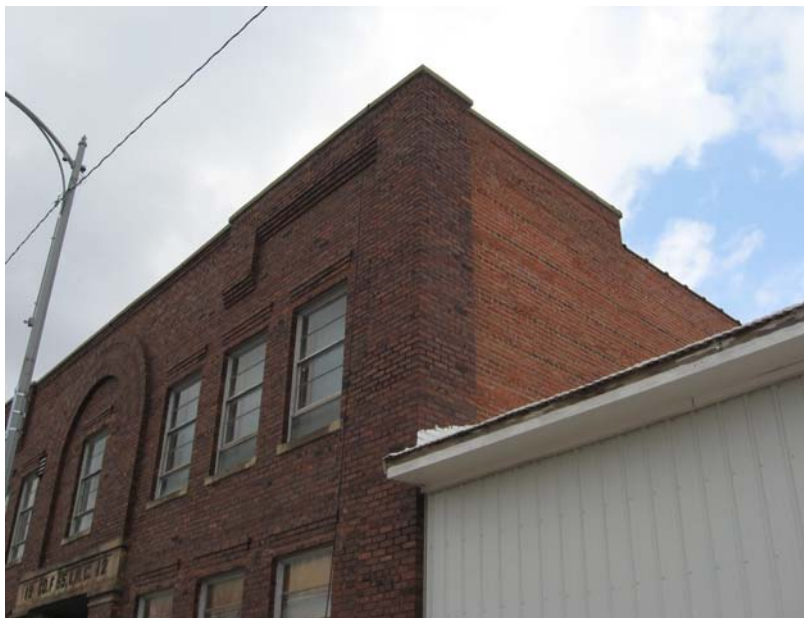
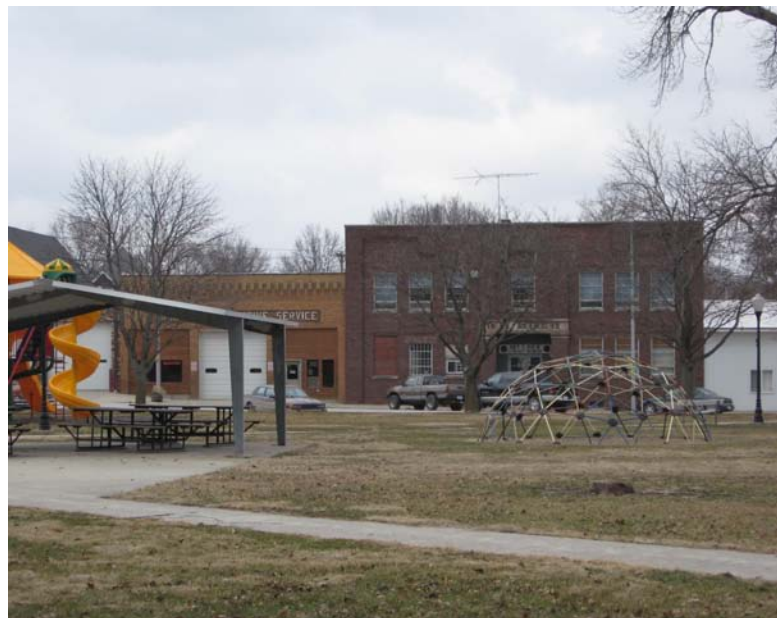
Clockwise from top left: North side of armory looking southeast, West facade, In context, Southeast corner.

ence from the Tudor Revival style of architecture then popular¹¹. The loss of the castellations and the replacement of the front façade windows have had an impact on the overall integrity of the exterior of the armory building. The interior retains good integrity, particularly in the gymnasium where the original features are largely intact¹². Although the spaces are intact, there has been some major deterioration of materials. The north part of the building has deteriorated increasingly in the last few years due to water damage. The tin roof has begun to fall off in many areas and paint has peeled even more, while insulation has begun to fall out as well. The wooden gym floor has seen significant water damage. The plaster on the wall has begun to fall off in large quantities in the northeast corner, thus exposing the brick underneath because of water damage, as well (Appendix 2). Overall, while impacted, the integrity is still sufficient to be considered eligible for its architectural significance because the overall plan and design of the front façade remains intact, particularly the round arched recessed entryway and fenestration.¹³
